Monitoring the performance of Accoya in different applications

René Klaassen¹, Bôke Tjeerdsma², René Hillebrink³

Keywords: joinery, bridge, sheet piles, acetylated radiate pine

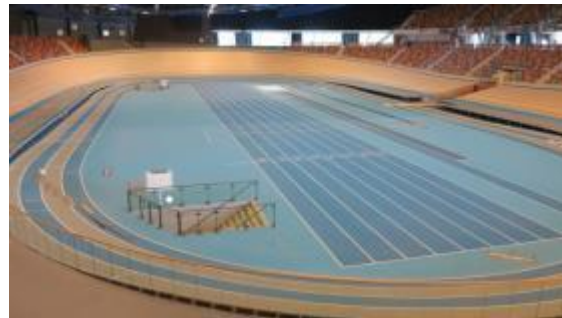
On both long sides, shutters are included for opening of the track to enable large equipment to enter the centre of the court, in the 250 m indoor cycle track (Figure 1). In summer the seams at both ends of the shutter are about 10 mm and in the winter they are 7 mm smaller (Figure 2). Calculated with respect to the length of the track, this means a longitudinal shrinkage of about 0.01%, which is ten times less compared to non-treated wood. The moisture content of the modified wood under these indoor track conditions varies in the summer and winter period between 3 and 8%.

Figure 1: Cycle track with right an opening while the shutter is removed.

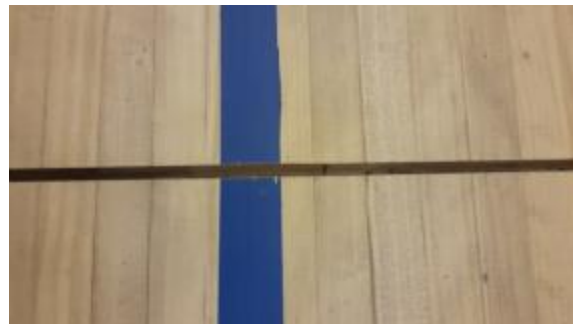
Figure 2: Interface of the shutter and the cycle track, showing the size of the seams in the winter.

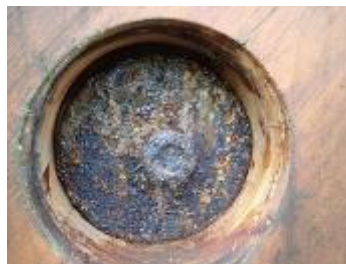
In some of the projects (Den Haag 2007, Sneek 2008, Wageningen 2012 and Almere 2014) heavy corrosion was seen. In all of these projects, the corrosion was related to extreme water load and the use of non-corrosion resistant metals. In Den Haag the joinery was stored unprotected for a longer period. In the bridge the water uptake in the outer layers of the wooden beams is high, resulting in free water around the metal connection parts (Figure 3). The high corrosion in the sheet doors, which open to the outside, in the 2012 Wageningen project was caused by use and construction. Frequently the sheets doors stood open for a longer time and the connection between the metal locks and the wooden part acted as a funnel causing water storages around the metal door clasp (Figure 4). In case of joinery in the Almere project, problems with condensation, causes water storage around the metal locks (Figure 5).

Based on our findings we concluded that heavy water load is the main feature for causing metal corrosion in acetylated joinery timber rather than a general material characteristic of Accoya itself.

Figure 3: Bridge and its metals components. Behind a removed wooden plug water accumulated appeared causing corrosion on the metal parts.

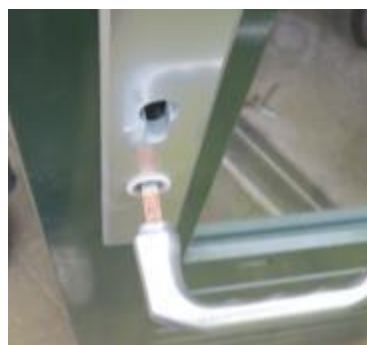
Figure 4: Sheet door which stood frequently open causing water accumulation in the lock resulting in corrosion on the metal parts.

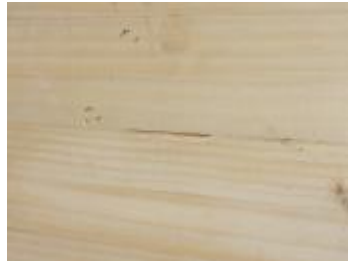
Cracks caused by or during the acetylation treatment were not seen in any of the projects. For both cycle tracks some of the delivered timber beams during the building phase, included drying cracks resulting in shallow thin peels. The number of these cracks did not increase in time, after the timber was included under tension in a curved position (Figure 8).

Figure 8: Beam in cycle track Assen with a removed shallow peel which was a result of a drying crack.

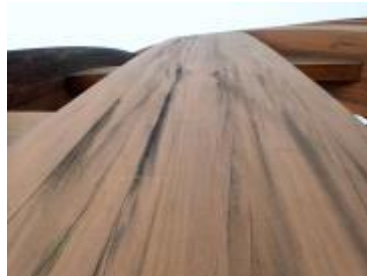
In joinery no cracks were seen other than those related to the production (e.g. timber was split because of the use of too high force or the use of too narrow connecting parts). Development of new cracks during the use phase were only seen in the bridge (Sneek 2008) and only in the larger beams (e.g. the king post). In general the cracks were shallow (< 15 mm deep) but in the middle of the two central columns deeper cracks

until 25 mm over several centimetres appeared (Figure 9). Mechanical evaluations showed that none of these cracks had a negative impact on the stability of the bridge, however they enable free water to penetrate deeper into the wood with the risk of water accumulation in the construction.

The cause of the presence of these deeper cracks is not clear and needs further research, but relationships are suggested with the extreme large timber dimensions and heavy exposure.

Figure 9: postcentral column with cracks.

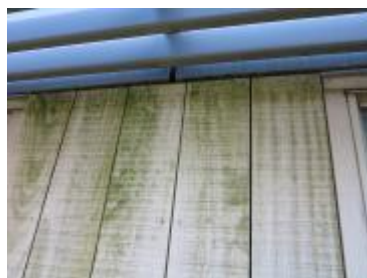
Because of the acetylation treatment the timber has a low equilibrium moisture content. In exterior joinery without exceptional local water load caused by open connections or internal water condensation, the recorded moisture content normally was between 2.5 and 4.5%. However the moisture content can be much higher near local moisture load caused by damage, resulting in wet conditions of the acetylated wood for longer periods. The acetylated wooden cell wall is more hydrophobic leading to a disturbed transport or diffusion of water inside the wood. This disturbed transport of water causes a slow release of moisture and water accumulation in wood, leading to slower drying characteristic of acetylated wood compared to untreated wood. Although, long term high moisture content did not result in decay or substantial swelling, it can give some unwanted side effects. In claddings (Wageningen 2008) with a high water load because of unsealed upper cross surfaces, resulted in mould and moss growth on the paint layer (Figure 10).

Figure 10: Moss and fungal growth on paint layer of wet timber.

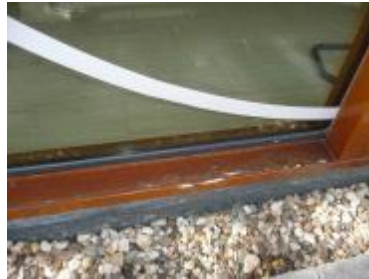
Window frames which were not handled properly in the building phase (Wageningen 2008) caused deep penetration through the end grain of free water into the cell lumen of the timber. During the first several years, these high moisture contents, combined with solar exposure caused severe de-adhesion of the paint. Only after several attempts to repaint the window frames, a stable situation was reached in 2017 (Figure 11).

Figure 11: Window frame with high moisture content causing paint damage.

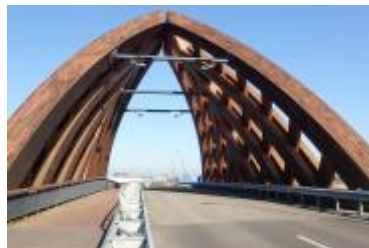
The moisture measurements done in the bridge (Sneek 2008) showed that free water uptake also can take place through the longitudinal surfaces of the timber. After almost 10 years the thin paint layer of the wooden elements of the bridge has lost its water protecting function. The sealing of the timber connections were still functioning properly (Figure 12). It is suggested that the high moisture contents in the outer layer of the beams (e.g. < 20%) are a result of free water uptake mainly by the tangential surface and slow drying of wet acetylated wood.

Figure 12: bridge with degraded paint layer.

In case of joinery it is concluded that the fast water uptake, through the end grain surfaces, leading to free water in the wood, should be avoided and special methods or maintenance instructions should be developed in order to remove free water in acetylated timber building products.

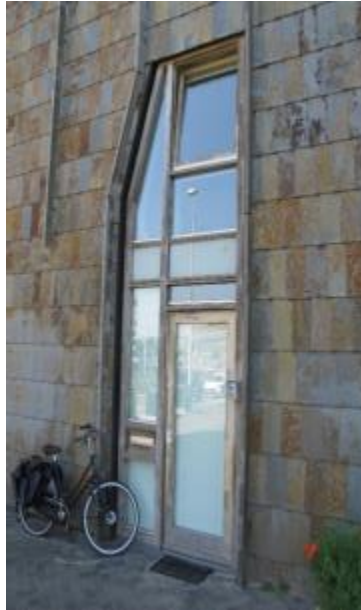
Inspection of a 6 year old project with un-coated joinery and cladding revealed a clean and grey impression of the wood surface (Amsterdam 2012, Figure 13). Caused by UV radiation over a period of 6 years, the fibres on the exposed wood surface of the joinery were only degraded in an outside layer with a thickness of several cell layers deep. However depending on the degree of exposure, the surface was darker because of dirt adhesion and mould growth. On locations where the wood was exposed for longer time to high relative humidity, additional moss and algae growth and more extensive mould discoloration was seen (Figure 14). Local differences in discoloration were on some places quite extensive resulting from grooves in the joinery itself or expanded materials like bricklayers (Figure 15). Furthermore in some cases the blocks between the finger

joints react differently on exterior exposure (Figure 13). It is unclear if small moisture content differences or if the timber quality itself is causing this effect.

Figure 13: Unpainted joinery, clean, partly homogeneous discoloured, partly heterogeneous e.g. door.

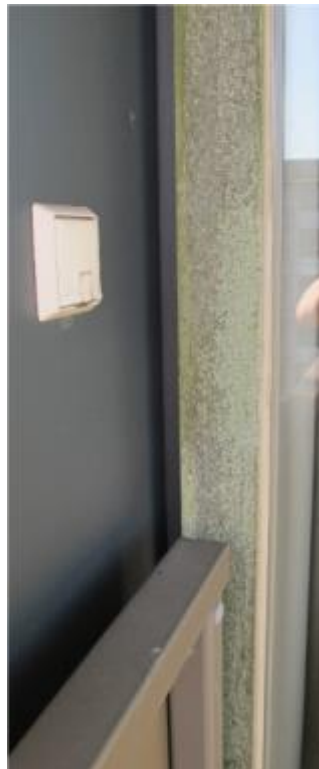
Figure 14: Unpainted joinery with lichen on moisture areas.

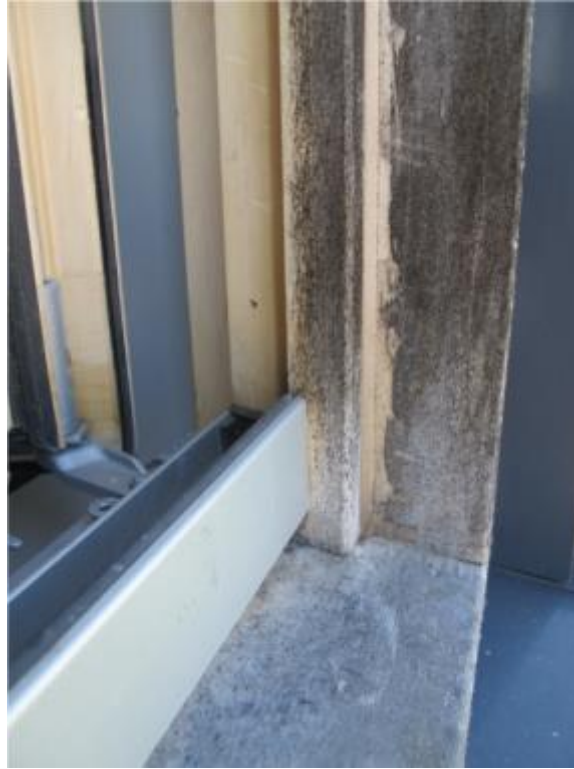
Figure 15: differences in discolorations and mould growth.

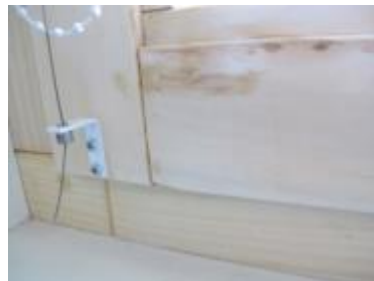
After six years in use it is remarkable that the indoor surface of the joinery is unaffected by exposure and use (Figure 15, 16, 18). The inspected surface of the indoor surface of the timber was clean and whitish. Only on a limited number of locations and always near connections brown discolorations were seen (Figure 17). It is suggested that this discoloration is caused by water transfer from outside inwards.

Figure 16: Clean inside timber surface with some brown discolorations.

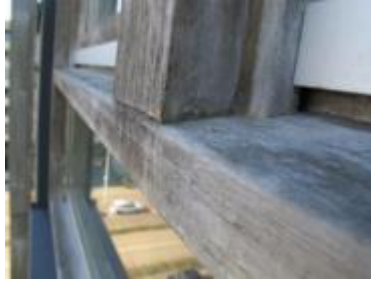
Figure 17: Clean and homogeneous discoloration (greying).

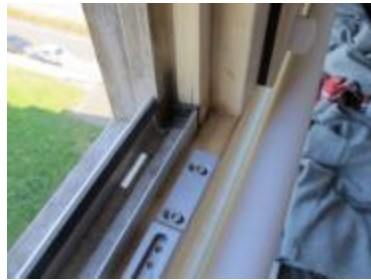
Figure 18: Clean joinery and non-corroded locks.
