Assessment report: State of the wooden construction, fresh water marina, Akkrum

Report code: 20.0382

Date: December 11th, 2020

Principal: Probos Foundation
Hollandseweg 7 J
6700 AG Wageningen

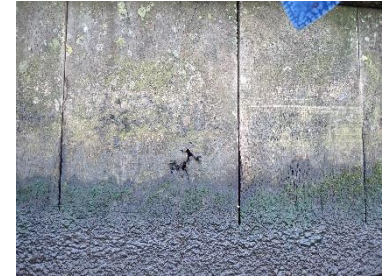
Sheet piles 1a, okan, start from the 25th sheet pile along the main river pathway (after the corner with the combination sheet piles, no. 3), thickness 40 mm, width 255 mm, 26th sheet width 155 mm, following sheets with variable width. Interlocked grain, fine wood structure, compared to all other sheet piles it is remarkable that there was almost no algae, mosses or plant growth; good condition (visually no decay and density profiles show weak decay only in outermost parts on top landside 15 mm, lower at waterside 10 mm). 27th sheet is sampled (M4) and density profiles were made.

Remarkable little attached growth of algae and mosses

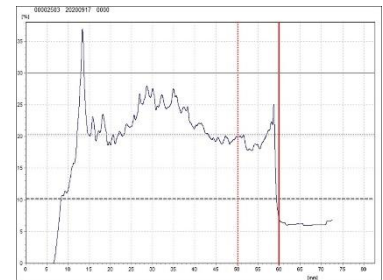
2505: no significant decay only weak decay landside 15 mm

2504: thickness 40 mm; no significant decay only weak decay waterside 10 mm

2503: no significant decay only weak decay waterside 10 mm

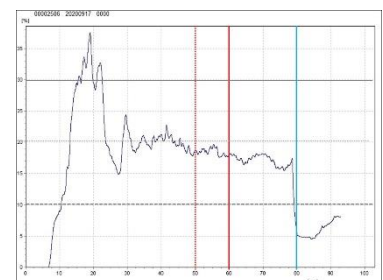
Sheet piles 1b, azobé, starts after sheet piles 1a and have variable widths of 240, 310, 320 and 340 mm. They have interlocked grain, fine wood structure, condition good (no visible decay, density profiles show only weak decay top 10 mm at landside, middle 10 mm at waterside and water level 5 mm in middle). 27th sheet is sampled (M5) and density profiles were made.

2508: no significant decay only weak decay landside 10 mm

2507 thickness app. 50 mm, no significant decay, only weak decay waterside 10 mm

2506: no significant decay, only weak decay behind a thin hard layer in 5 mm

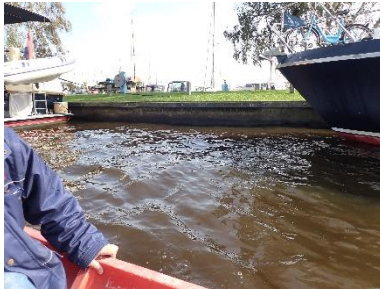
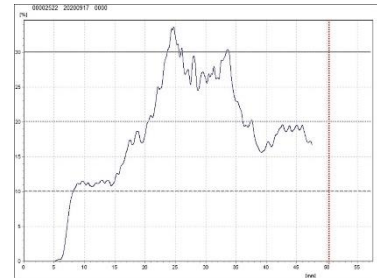
Sheets piles 1d, tali, next after 1c sheet piles are located between pole 15 and 16. Thickness at least 40 mm. Condition relative good (visual no decay, density profiles moderate decay 10 mm deep waterside from 150 mm downwards, weak decay landside 5-15 mm top to water level, and middle top to 300 mm downwards 15 mm); the same sheet pile is sampled (M7) as from which the density profiles were made.

2527: no significant decay, only weak decay landside 5 mm and middle 15 mm

2521 thickness more than 40 mm; moderate decay waterside 10 mm, weak decay landside 15 mm and middle 15 mm

2522: moderate decay waterside 10 mm, weak decay landside 15 mm rest no significant decay

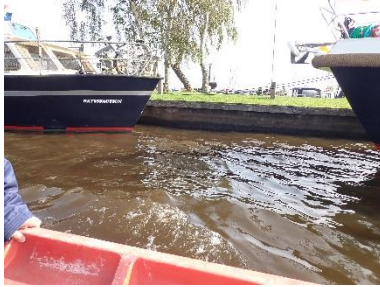
Sheet piles 1e, okan, next few sheets piles after 1d sheet piles are located around pole 13. Thickness 50 mm. Condition relative good (visual, awl at top landside 1-2 mm decay, density profiles show weak decay in the middle and at the top landside 20 mm, and at the water level waterside 15 mm); the same sheet pile is sampled (M8) as from which the density profiles were made.

2532: weak decay landside 20 mm and middle 10 mm, rest no significant decay

2533 thickness app. 50 mm; weak decay waterside 15 mm and middle 20 mm, rest no significant decay

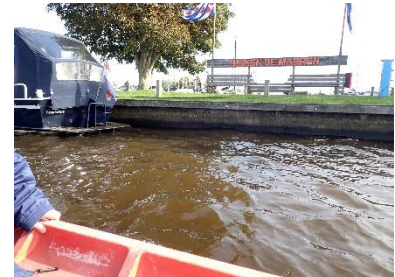
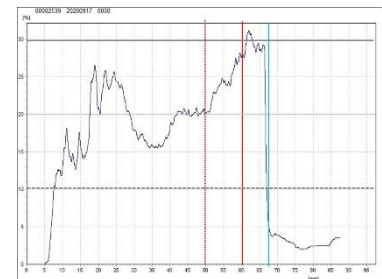
Sheet piles 1g azobé, next few sheets after 1f sheet piles are located around pole 7. Thickness 50 mm. condition questionable (visual / awl top landside white rot 30 mm deep, density profiles show moderate decay in the upper 300 mm at the landside 10-20 mm and in the middle part 15-25 mm, at the water level the decay is less weak); the same sheet pile is sampled (M10) as from which the density profiles were made.

2537: moderate decay landside 10 mm, middle 25 mm, weak decay waterside 15 mm

2538 thickness app. 50 mm, decay moderate landside 20 mm, moderate -severe middle 15 mm, rest (waterside) no significant decay 25 mm

2539: weak decay waterside 10 mm, middle 35 mm, rest (landside 15 mm) no significant decay

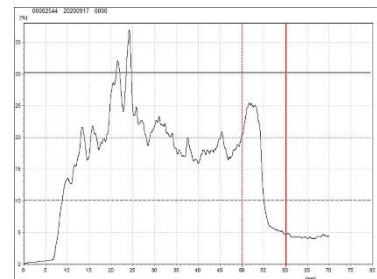
Sheet piles 1h, araracanga, next few sheets after 1g sheet piles are located around pole 5. Thickness 50 mm. Condition good (visual / awl top landside superficial decay, density profiles no significant decay, only weak decay at top both land-and waterside in 5 mm, and at the water level waterside 10 mm and middle 20 mm); the same sheet pile is sampled (M11) as from which the density profiles were made; this is the last pile of this species.

2540: no significant decay, besides weak decay landside behind hard peal 5 mm, waterside 5 mm.

2542 thickness app. 50 mm, no significant decay

2544: weak decay waterside 10 mm, middle 20 mm, rest no significant decay

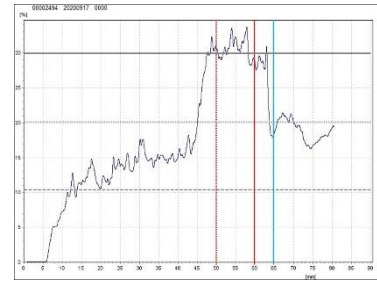
Sheet pile 3, combination sheet pile (Van Swaay), situated over the full short end of the island. The upper part is angelim vermelho, thickness 45 mm, width approximately 180 mm, rabbet depth 20 mm, 22 mm wide and the lower part is probably a softwood. Most upper parts are sound, no decay, a few upper parts show some bugling and occasionally some plant growth through the nails.. The condition of the eighth sheet from the corner with the frontside of the island, was questionable (visually degraded, density profiles show weak to moderate decay on waterside at middle) (M1, lost its smell), adjacent sheet was good (visually no decay, density profiles show weak decay in top 15 mm on landside, 10 mm middle), (M2). Both samples confirm the wood species.

2498: landside no significant decay, weak decay middle 25 mm, moderate decay waterside 10 mm

2495: no reliable thickness estimation here because of skewed measurement; landside no significant decay, weak decay middle 10 mm, moderate decay waterside 25 mm

2494: landside no significant decay, weak decay in middle and waterside 35 mm

Degraded sheet (M1)

Sheet pile with no visual degradation (M2)

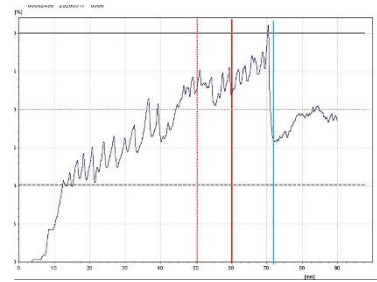
2499: landside weak decay in 15 mm, 10 mm in middle, rest no significant decay

2497: no reliable thickness estimation here because of skewed measurement; weak decay in middle 10 mm, rest no significant decay
just below purlins (water side, 30 cm from head)

2496: no significant decay for both water and landside

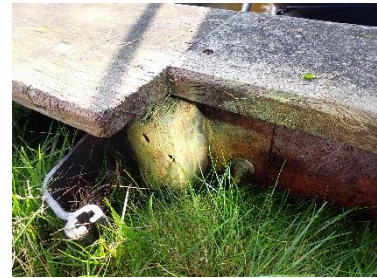
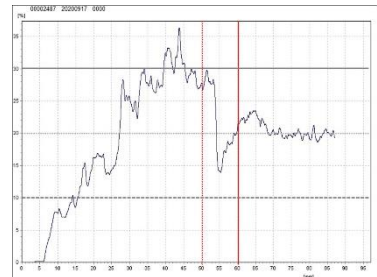
Sheet pile 4b, three combination sheet piles softwood with an upper part of angelim vermelho (specific smell), thickness 53 mm, width 178 mm, rabbet depth 24 mm, moisture content (at density 0,90 g/cm³) landside 14%, waterside high 20-21%, in good condition (only some weak decay in 10 mm landside top; 15 mm waterside and 5 mm middle; 20 mm waterside and 2 mm middle on water level). Finger joints to the supposed lower spruce part were not detected visually or as an uneven connection.

2492: landside weak decay in 10 mm, rest no significant decay

2488: waterside weak decay in 15 mm, 5 mm in middle, rest no significant decay

2487: waterside weak decay in 20 mm, 2 mm in middle, rest no significant decay

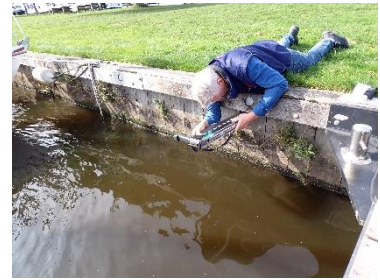
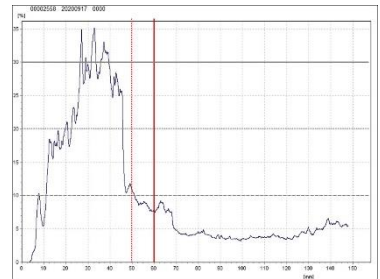
Sheet piles 9, reused azobé sheet piles. Thickness 50 mm. Condition good (visual / awl top landside superficial decay, density profiles no significant decay, only weak decay at top both land-and waterside in 5 mm, and on the water level waterside 10 mm and middle 20 mm); the same sheet pile is sampled (M16) as from which the density profiles were made, is the last pile of this species. Cover plank severely degraded with many ants.

2556: no significant decay, besides weak decay landside behind hard peal 5 mm, waterside 5 mm.

2557 thickness app. 50 mm, no significant decay

2558: weak decay waterside 10 mm, middle 20 mm, rest no significant decay

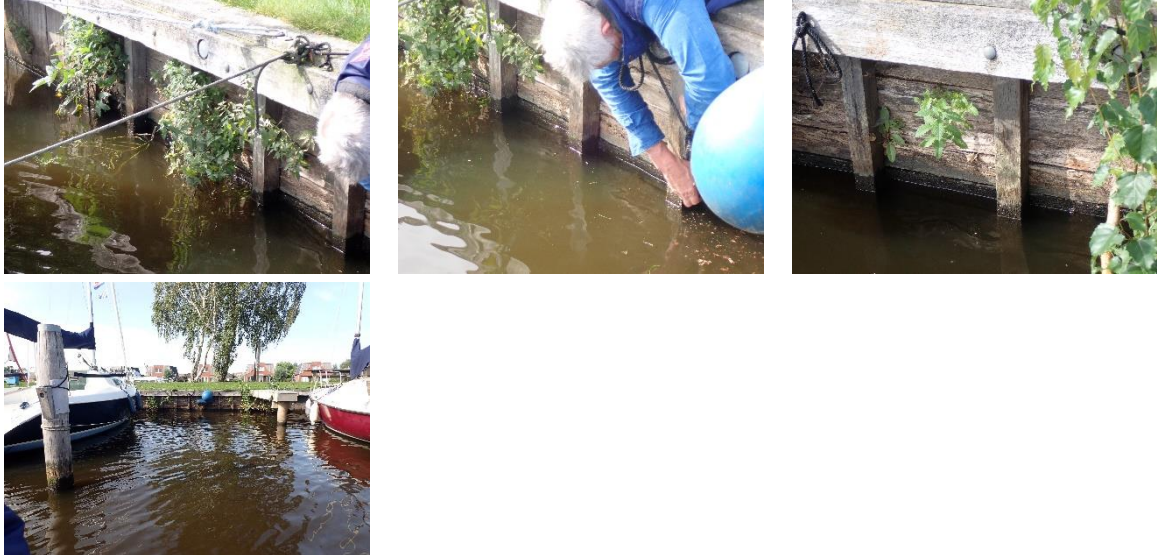
Location 10, robinia bulkhead and kopie (cupiuba) poles. Condition poles good (visual / awl above water part is hard), bulkhead bad (severe decay), wood sample M15. Extensive plant growth was seen.

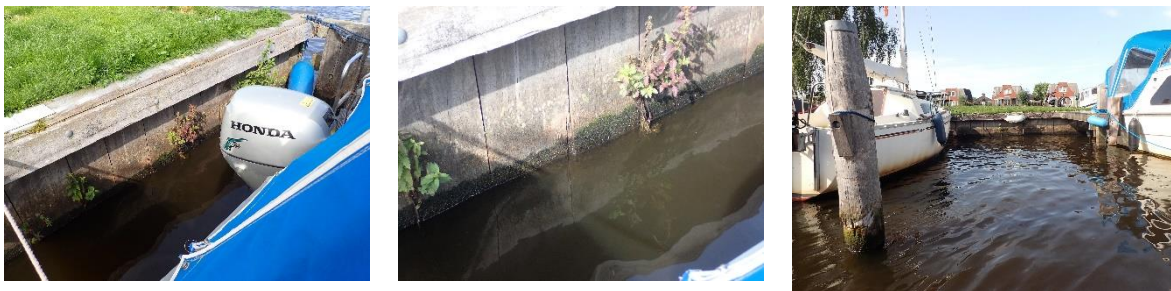
Sheet piles 11, azobé, sheets are a supposed continuation of the reused azobé under 9 until the corner of the island. Thickness 40 mm. Some plants grow through the seams, wall is coherent. Condition questionable (visual / awl waterside hard, landside not reachable, density profiles show moderate decay in upper part and in lower parts weak decay land- and waterside 5-10 mm; the same sheet pile is sampled (M14) as from which the density profiles were made, is the last pile of this species.

2553: weak decay over the full thickness, hard peal waterside.

2554 thickness app. 40 mm, no significant decay, only weak decay land- and waterside 5 mm, HV just below purlins (water side, 30 cm from head)

2555: no significant decay, only weak decay land- and waterside 10 mm
WL just above water level (water side)

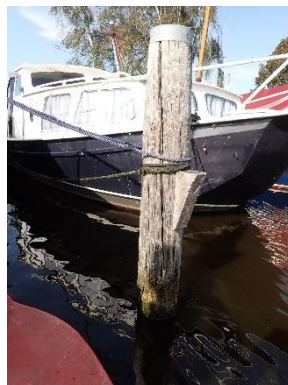
Third pole west from the entrance landing stage, larch

Round softwood pole, above the water line, one large crack and some small cracks, no significant fungal decay. On the water air line 10-20 mm decay, below the water surface sound. Wood sample (MP1) was taken.

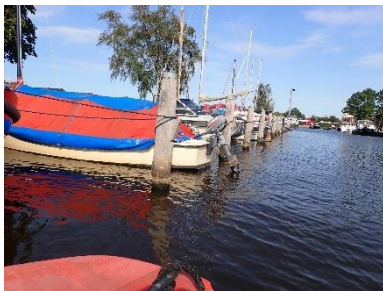
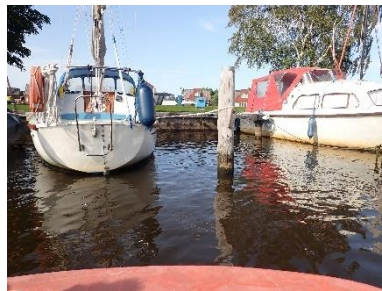
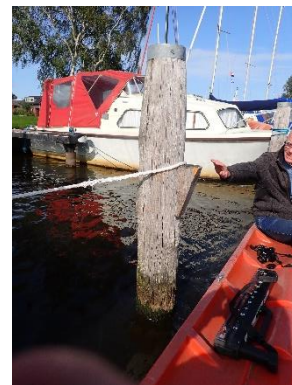
Round hardwood poles, diameter 24 cm in the part above the water level with many cracks perpendicular to the fibre angle, many small holes (< 1 mm in diameter longitudinal or cross cut) of pinhole borers, further no significant decay, wood sample (MP4).

Left picture: poles at the right of but close to the entrance landing stage, middle and right pictures: 3rd pole from which sample MP4 was taken

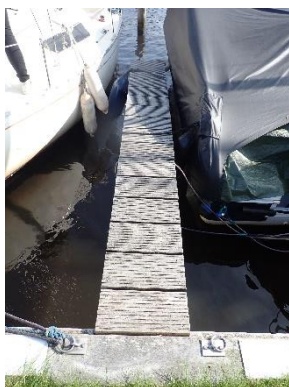
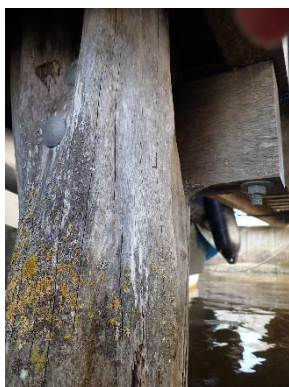
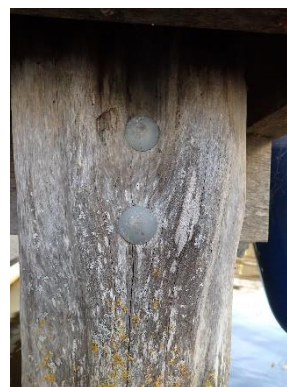
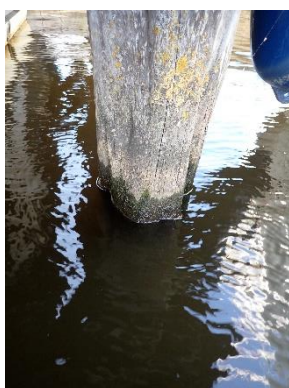
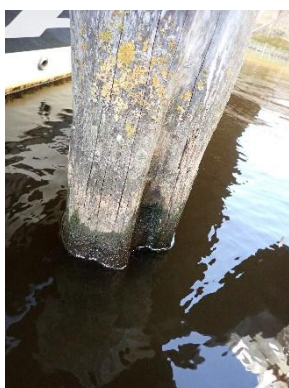
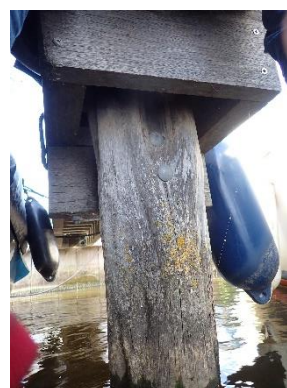
Landing stage 13 gangs boards of several species (manbarklak, angelim pedra, aldina, faveira amargosa), horizontal construction beams based on the goms flecks identified as angelim pedra, and the acariquara pole with the original tree trunk shape (non-machinable, e.g. non sawn). The condition of gang boards, horizontal construction beams and pole is good.
