Klaassen - Bakterienbefall von Holz - Schutzmechanismen an Gebäuden und Hafenanlagen

Bacterial decay of wood – protection mechanisms for buildings

R.W.W.M. Klaassen, J.G.M. Creemers (SHR Timber Research Wageningen)

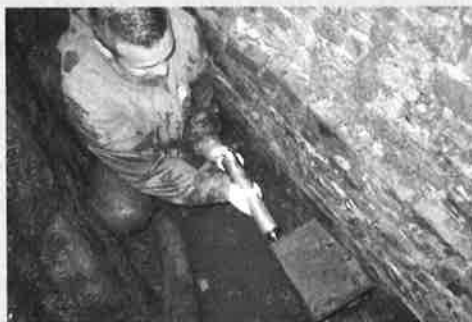
The test hammer is an apparatus that shoots a needle like pen (5 mm in round diameter and 50 mm length) into the wood. The velocity of the pen is calibrated

Figure 1: Test hamer

to be 5,05 ($\pm 0,11$) m/s and the weight of the needle block is 460 (± 39) g. The execution of the measurements with the test hammer are easy and quick, also in a watery environment like a foundation pit. This enables the researcher to achieve several measurements of each of the wooden elements of the foundation construction (Fig. 1). The test hammer is developed to indicate the thickness of the soft shell, which is the outermost layer of a wooden element that is wood severely degraded by bacteria. It is assumed that bacteria degrade wooden elements homogeneously from the outside towards the inside.

As the soft shell lost more than 80 % of its strength the pen of the test hammer always fully penetrates this layer. In situations where the bacterial decay is not active, there is a sharp boundary from the soft shell towards the sound, strong timber. The penetration depth of the pen is in this situation always ± 5 mm around

this boundary. However, in situations where the bacterial decay is active, there is a gradual increase in strength from the soft shell until the sound timber. In this situation, the penetration depth of the pen is less accurate. Not only the severely degraded wood is penetrated but also a part of the wood where the degree of decay is less. So in these situations the penetration depth of the pen can be deeper than the depth of the initial bacterial decay in the pile.

Therefore the interpretation of the measurements with the test hammer should always be done in combination with the wood research of the increment core which makes the gradient of decay visible.
