Assessment report: State of the wooden construction, fresh water marina, Akkrum

Report code: 20.0382

Date: December 11th, 2020

Principal: Probos Foundation
Hollandseweg 7 J
6700 AG Wageningen

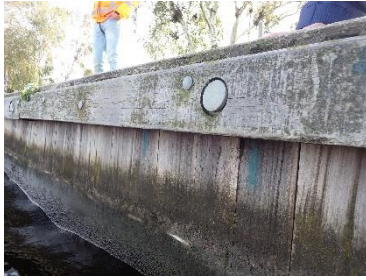
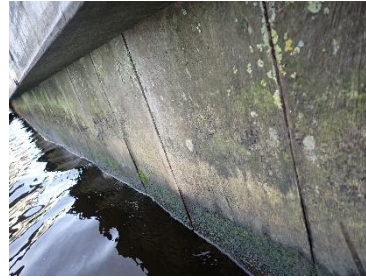
Sheet piles 1a, okan, start from the 25th sheet pile along the main river pathway (after the corner with the combination sheet piles, no. 3), thickness 40 mm, width 255 mm, 26th sheet width 155 mm, following sheets with variable width. Interlocked grain, fine wood structure, compared to all other sheet piles it is remarkable that there was almost no algae, mosses or plant growth; good condition (visually no decay and density profiles show weak decay only in outermost parts on top landside 15 mm, lower at waterside 10 mm). 27th sheet is sampled (M4) and density profiles were made.

Remarkable little attached growth of algae and mosses

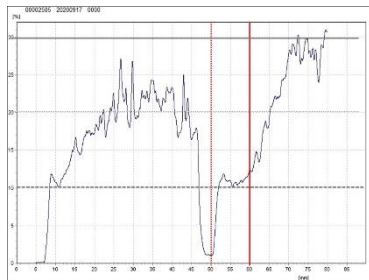
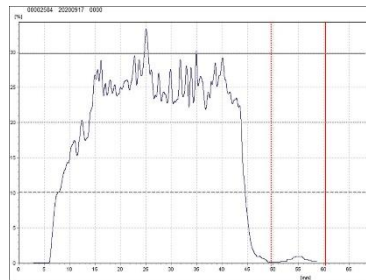
2505: no significant decay only weak decay landside 15 mm

2504: thickness 40 mm; no significant decay only weak decay waterside 10 mm

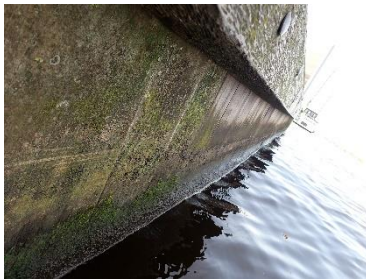
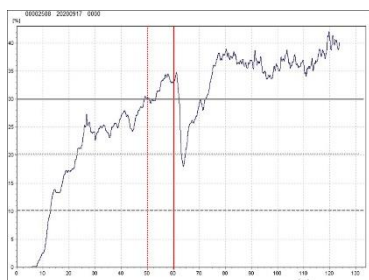
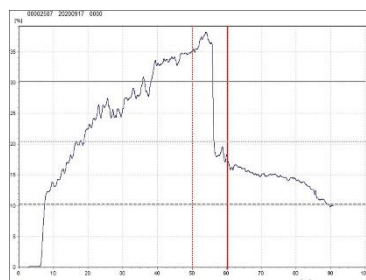
Sheet piles 1b, azobé, starts after sheet piles 1a and have variable widths of 240, 310, 320 and 340 mm. They have interlocked grain, fine wood structure, condition good (no visible decay, density profiles show only weak decay top 10 mm at landside, middle 10 mm at waterside and water level 5 mm in middle). 27th sheet is sampled (M5) and density profiles were made.

2508: no significant decay only weak decay landside 10 mm

2507 thickness app. 50 mm, no significant decay, only weak decay waterside 10 mm

2506: no significant decay, only weak decay behind a thin hard layer in 5 mm

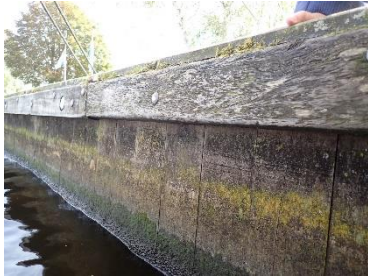
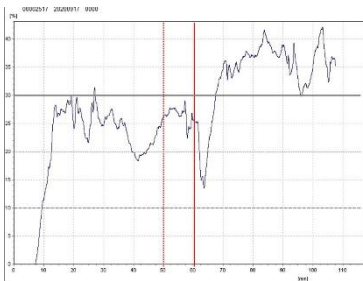
AB upper part (land side, approximately 15 cm from head)

Condition relative good (visible/ awl at top pile landside 5 mm decay, density profiles show only weak decay in the middle parts, most prominent in the upper 250 mm); the same sheet pile is sampled (M6) as from which the density profiles were made.

2517: no significant decay, only weak decay in middle 10 mm.

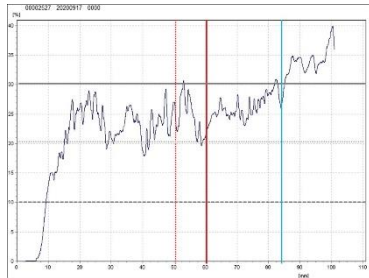
AB upper part (land side, approximately 15 cm from head)

Sheets piles 1d, tali, next after 1c sheet piles are located between pole 15 and 16. Thickness at least 40 mm. Condition relative good (visual no decay, density profiles moderate decay 10 mm deep waterside from 150 mm downwards, weak decay landside 5-15 mm top to water level, and middle top to 300 mm downwards 15 mm); the same sheet pile is sampled (M7) as from which the density profiles were made.

2527: no significant decay, only weak decay landside 5 mm and middle 15 mm

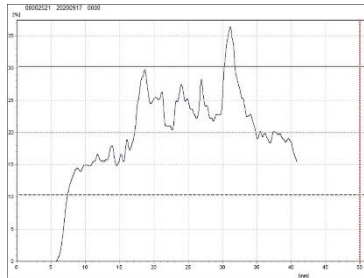
HV just below purlins (water side, 30 cm from head)

2521 thickness more than 40 mm; moderate decay waterside 10 mm, weak decay landside 15 mm and middle 15 mm

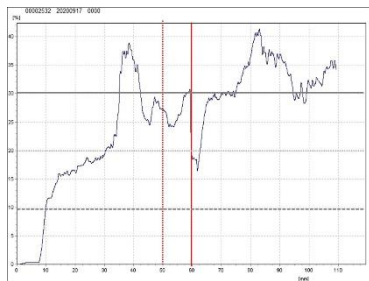
AB upper part (land side, approximately 15 cm from head)

Sheet piles 1e, okan, next few sheets piles after 1d sheet piles are located around pole 13. Thickness 50 mm. Condition relative good (visual, awl at top landside 1-2 mm decay, density profiles show weak decay in the middle and at the top landside 20 mm, and at the water level waterside 15 mm); the same sheet pile is sampled (M8) as from which the density profiles were made.

2532: weak decay landside 20 mm and middle 10 mm, rest no significant decay

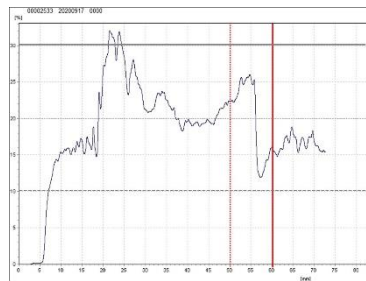
HV just below purlins (water side, 30 cm from head)

2533 thickness app. 50 mm; weak decay waterside 15 mm and middle 20 mm, rest no significant decay

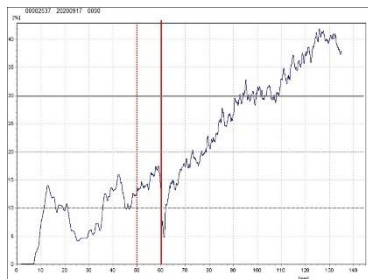
upper part (land side, approximately 15 cm from head)

2537: moderate decay landside 10 mm, middle 25 mm, weak decay waterside 15 mm

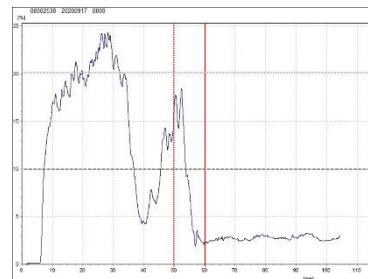
just below purlins (water side, 30 cm from head)

2538 thickness app. 50 mm, decay moderate landside 20 mm, moderate -severe middle 15 mm, rest (waterside) no significant decay 25 mm

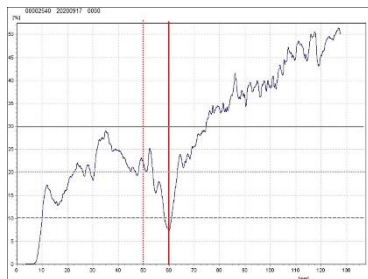
upper part (land side, approximately 15 cm from head)

Sheet piles 1h, araracanga, next few sheets after 1g sheet piles are located around pole 5. Thickness 50 mm. Condition good (visual / awl top landside superficial decay, density profiles no significant decay, only weak decay at top both land-and waterside in 5 mm, and at the water level waterside 10 mm and middle 20 mm); the same sheet pile is sampled (M11) as from which the density profiles were made; this is the last pile of this species.

2540: no significant decay, besides weak decay landside behind hard peal 5 mm, waterside 5 mm.

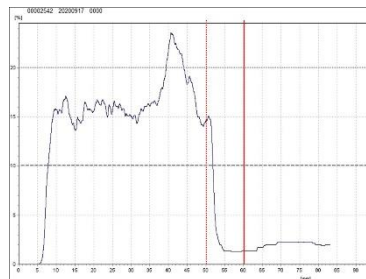
just below purlins (water side, 30 cm from head)

2542 thickness app. 50 mm, no significant decay

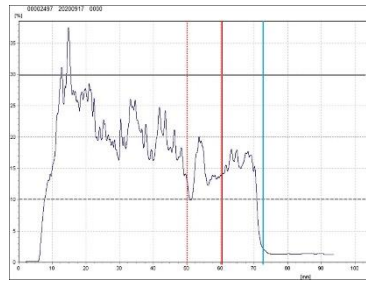
2497: no reliable thickness estimation here because of skewed measurement; weak decay in middle 10 mm, rest no significant decay
just below purlins (water side, 30 cm from head)

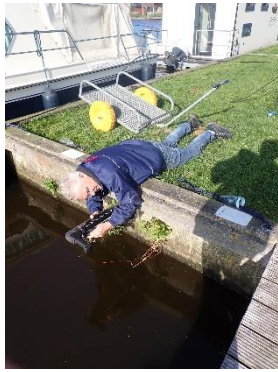
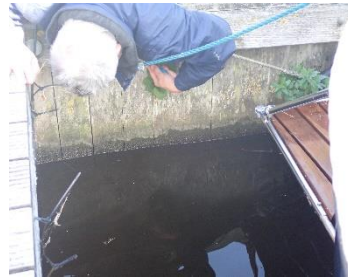
Sheet pile 4a, a combination sheet pile with Accoya

Approximately 39 combination sheet piles with Accoya, thickness 53 mm, width 132 mm, moisture content (at density 0,65 g/cm³) both land and water side 20-35%, no detectible decay, finger joints to the supposed lower spruce part were not detected (between cross surface Accoya and decking at least 5 mm space, some plant grow between the beams).

2493: no significant decay both water and landside

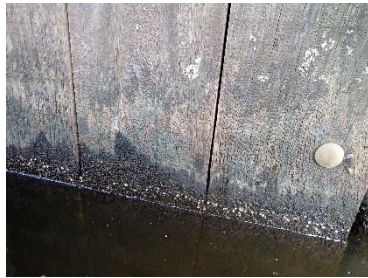
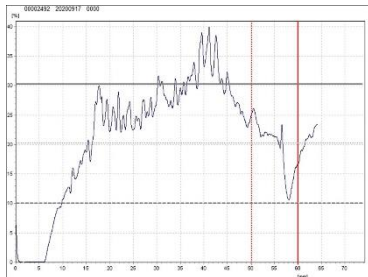
upper part (land side, approximately 15 cm from head)

Sheet pile 4b, three combination sheet piles softwood with an upper part of angelim vermelho (specific smell), thickness 53 mm, width 178 mm, rabbet depth 24 mm, moisture content (at density 0,90 g/cm³) landside 14%, waterside high 20-21%, in good condition (only some weak decay in 10 mm landside top; 15 mm waterside and 5 mm middle; 20 mm waterside and 2 mm middle on water level). Finger joints to the supposed lower spruce part were not detected visually or as an uneven connection.

2492: landside weak decay in 10 mm, rest no significant decay

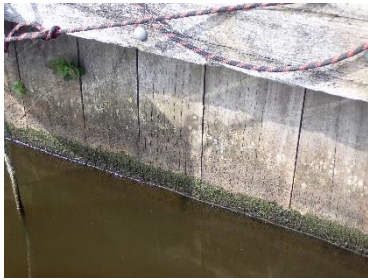
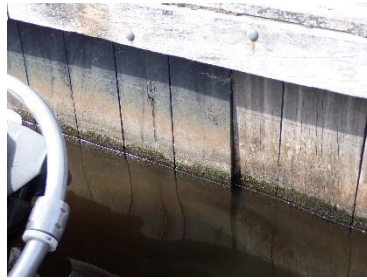
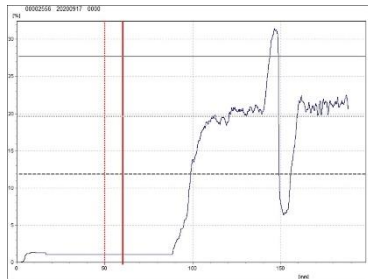
upper part (land side, approximately 15 cm from head),

Sheet piles 9, reused azobé sheet piles. Thickness 50 mm. Condition good (visual / awl top landside superficial decay, density profiles no significant decay, only weak decay at top both land-and waterside in 5 mm, and on the water level waterside 10 mm and middle 20 mm); the same sheet pile is sampled (M16) as from which the density profiles were made, is the last pile of this species. Cover plank severely degraded with many ants.

2556: no significant decay, besides weak decay landside behind hard peal 5 mm, waterside 5 mm.

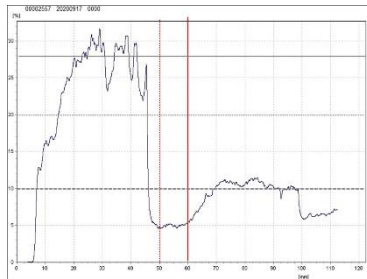
just below purlins (water side, 30 cm from head)

2557 thickness app. 50 mm, no significant decay

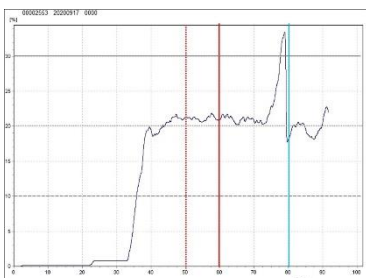
AB upper part (land side, approximately 15 cm from head)

Sheet piles 11, azobé, sheets are a supposed continuation of the reused azobé under 9 until the corner of the island. Thickness 40 mm. Some plants grow through the seams, wall is coherent. Condition questionable (visual / awl waterside hard, landside not reachable, density profiles show moderate decay in upper part and in lower parts weak decay land- and waterside 5-10 mm; the same sheet pile is sampled (M14) as from which the density profiles were made, is the last pile of this species.

2553: weak decay over the full thickness, hard peal waterside.

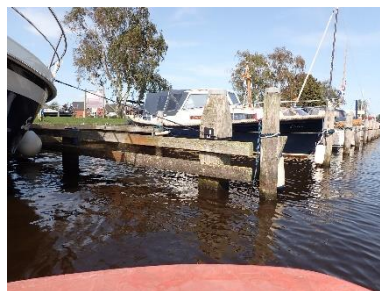
Fifth pole (MP2)

Round hardwood pole, no significant decay on and above the water line. Diameter poles approximately 22 cm. The density profile taken approximately 20 cm above the water line, shows a degraded outer most sheet of 20-30 mm. Wood sample (MP2) was taken.

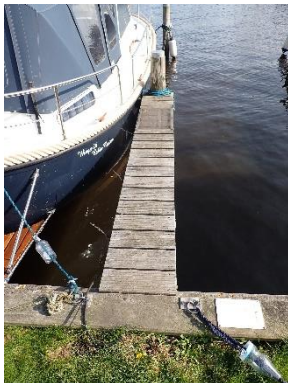
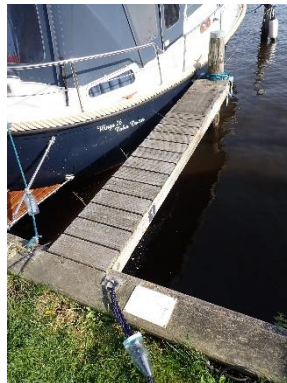
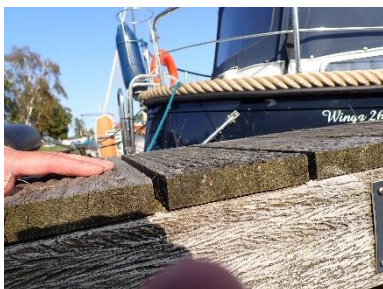
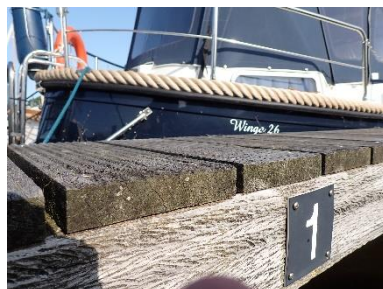
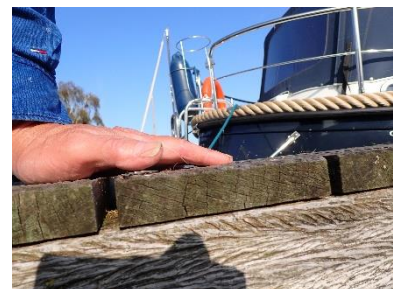
Landing stage 1 padoek in both gang boards and horizontal construction.

Condition good, sample taken from gangboard (S4), species confirmed

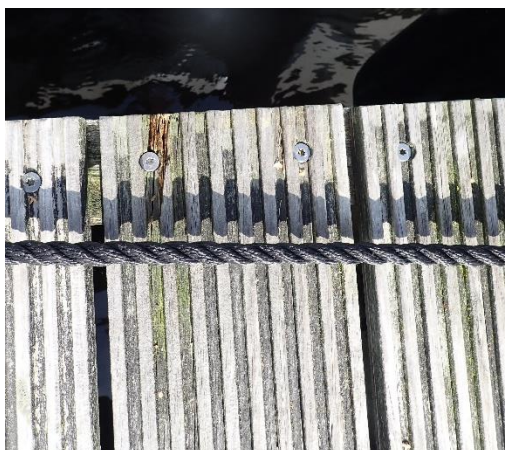
Landing stage 13 gangs boards of several species (manbarklak, angelim pedra, aldina, faveira amargosa), horizontal construction beams based on the goms flecks identified as angelim pedra, and the acariquara pole with the original tree trunk shape (non-machinable, e.g. non sawn). The condition of gang boards, horizontal construction beams and pole is good.
